PIC16(L)F1826/1827 Family Silicon Errata and Data Sheet Clarification

The PIC16(L)F1826/1827 family devices that you have received conform functionally to the current Device Data Sheet (DS41391D), except for the anomalies described in this document.

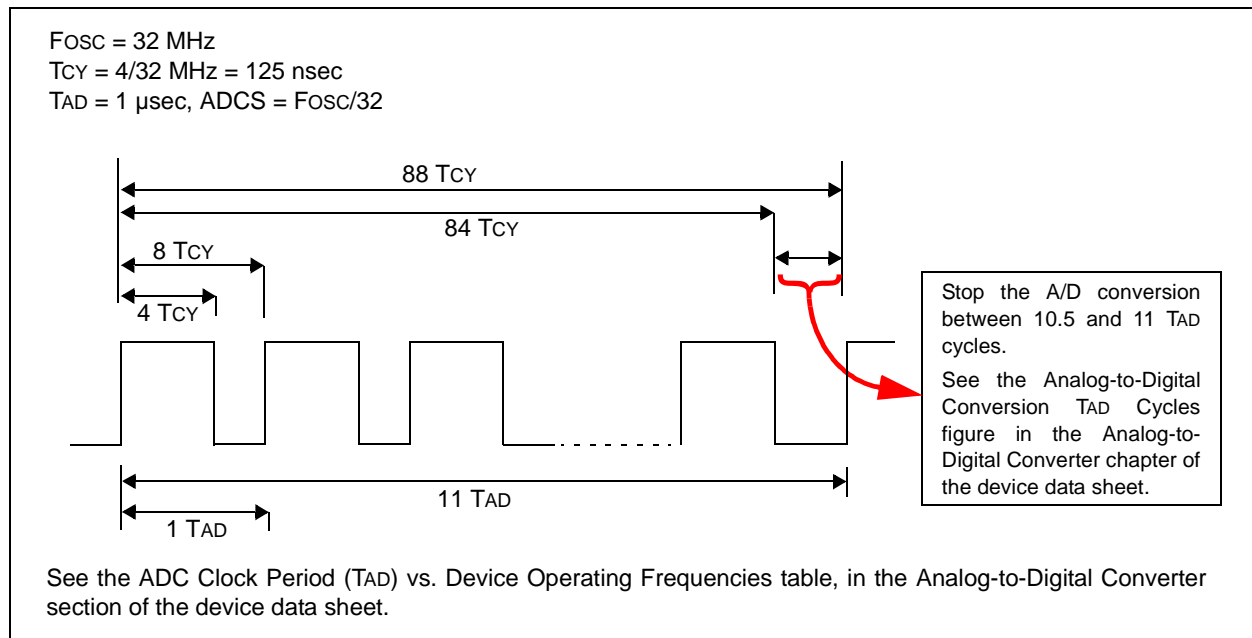
FIGURE 1: INSTRUCTION CYCLE DELAY CALCULATION EXAMPLE

An ADC conversion may not complete under these conditions:

1. When F_{OSC} is greater than 8 MHz and it is the clock source used for the ADC converter.
2. The ADC is operating from its dedicated internal FRC oscillator and the device is not in Sleep mode (any F_{OSC} frequency).

When this occurs, the ADC Interrupt Flag (ADIF) does not get set, the $\overline{GO/DONE}$ bit does not get cleared, and the conversion result does not get loaded into the ADRESH and ADRESL result registers.

In [Figure 1](#), 88 instruction cycles (T_{CY}) will be required to complete the full conversion. Each TAD cycle consists of 8 T_{CY} periods. A fixed delay is provided to stop the A/D conversion after 86 instruction cycles and terminate the conversion at the correct time as shown in the figure above.

Method 3: This method is provided if the application cannot use Sleep mode and requires continuous operation at frequencies above 8 MHz. This method requires early termination of an ADC conversion. Provide a fixed time delay in software to stop the A-to-D conversion manually, after all 10 bits are converted, but before the conversion would complete automatically. The conversion is stopped by clearing the $\overline{GO/DONE}$ bit in software. The $\overline{GO/DONE}$ bit must be cleared during the last $\frac{1}{2}$ TAD cycle, before the conversion would have completed automatically. Refer to [Figure 1](#) for details.

Note: The exact delay time will depend on the TAD divisor (ADCS) selection. The Tcy counts shown in the timing diagram above apply to this example only. Refer to [Table 3](#) for the required delay counts for other configurations.
